Manhole Inspection Summary

Manhole # S45C2_018MH

Insp Date: **12/18/07 7:59 AM**

Location Address: **3705 Everett St**

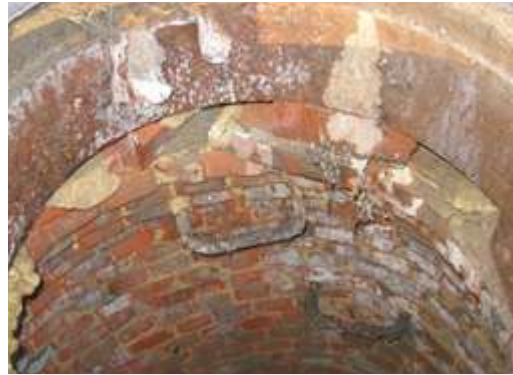
Defect 2

Condition: ☐ Sound ☐ Cracked ☐ Root Intrusion ☒ Loose Brick ☒ Deteriorated

Infiltration: ☐ None ☒ Joint ☐ Cracks ☒ Mortar ☐ Roots ☐ Wall

Loose/missing bricks

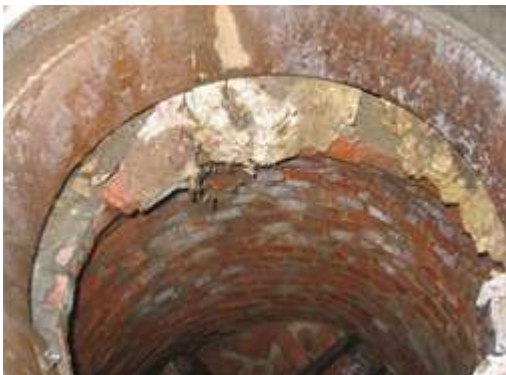
Defect 1

Frame Offset: **1** (in.) Condition: ☒ Sound ☐ Cracked ☐ Leaks

Frame offset/mortar

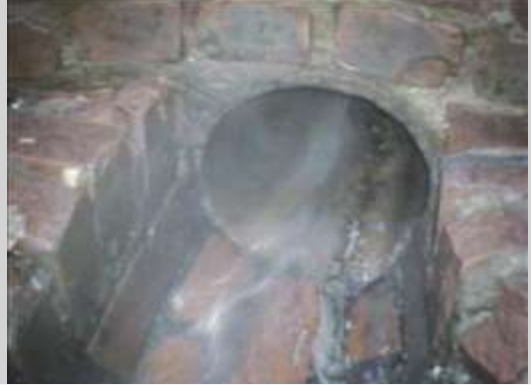
12 O'Clock Outflow

8 in. Circular Gravity Sewer
Pipe Out @ 12 O'Clock

Pipe Height: **9.6** (in.) Rod and Bar (Angled)
Pipe Material: **Clay** ☐ Pipe Lined
Invert Depth: **7.05** (ft.) Flow Characteristics: **Fast**
Deposits: ☒ None ☐ Mud ☐ Sludge ☐ Debris ☐ Grease
Silt Depth: (in.) Deposits Extent:
Infiltration: **None** Pipe Seal Cond: **Sound**

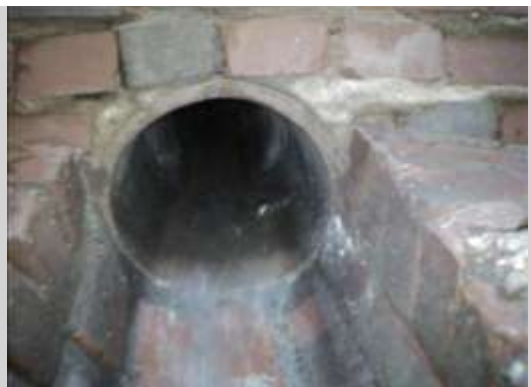
3 O'Clock Inflow

8 in. Circular Gravity Sewer
Pipe In @ 3 O'Clock

Pipe Height: **9.6** (in.) Rod and Bar (Angled)
Pipe Material: **Clay** ☐ Pipe Lined
Invert Depth: **6.59** (ft.) Flow Characteristics: **Fast**
Deposits: ☒ None ☐ Mud ☐ Sludge ☐ Debris ☐ Grease
Silt Depth: (in.) Deposits Extent:
Infiltration: **None** Pipe Seal Cond: **Sound**
